# Evaluating Reclaimed Mines and Heavy Metal Soil Contamination

Torin Matthews, Dr. Jacob Siebach

Department of Physical and Earth Sciences, Arkansas Tech University, Russellville, AR

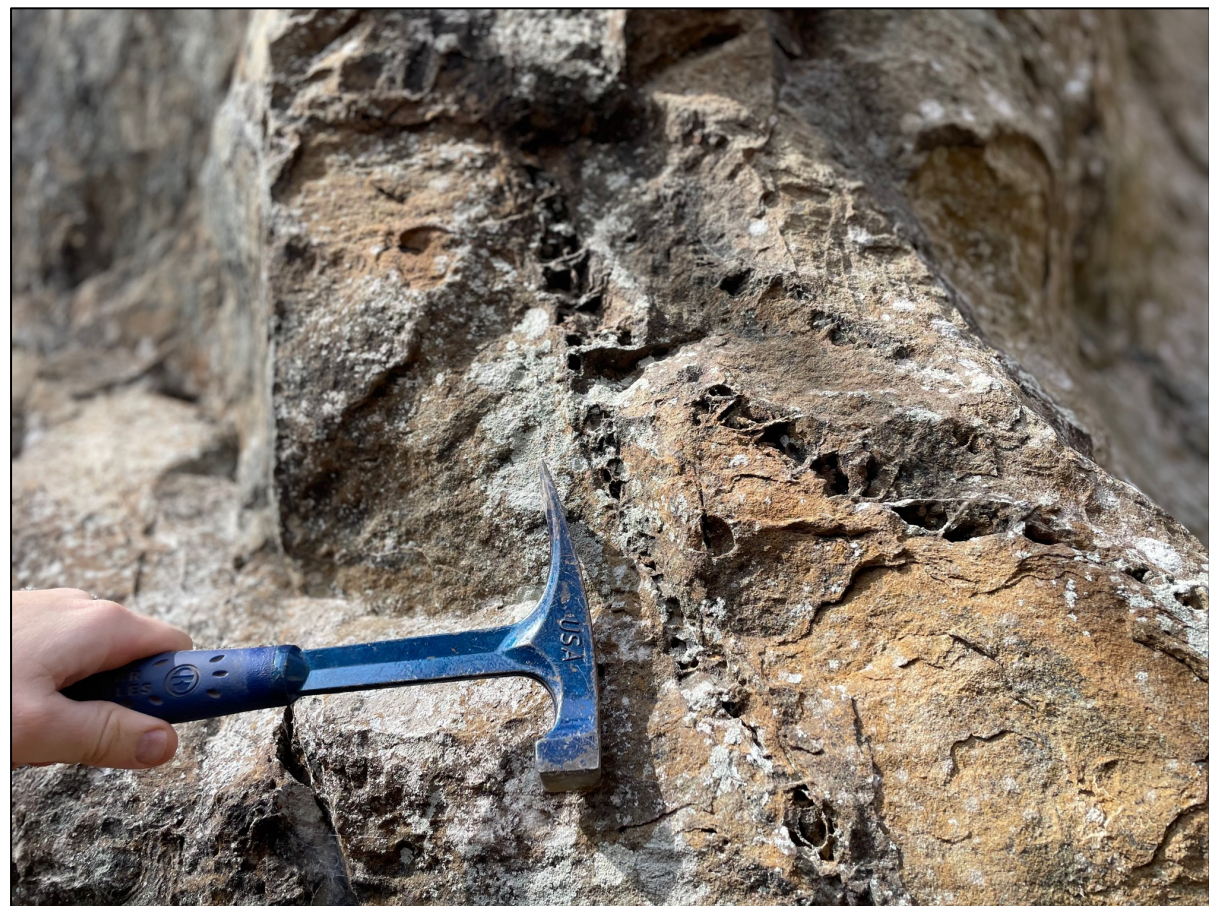
Figure 3 (left): Weathered boxworks structure

We found five hand samples of galena on rocks in the stream (Fig. 3). We also found boxworks, which are typical of the weathering of sulfide minerals, indicating the past presence of sulfide minerals in the location (Fig. 4).

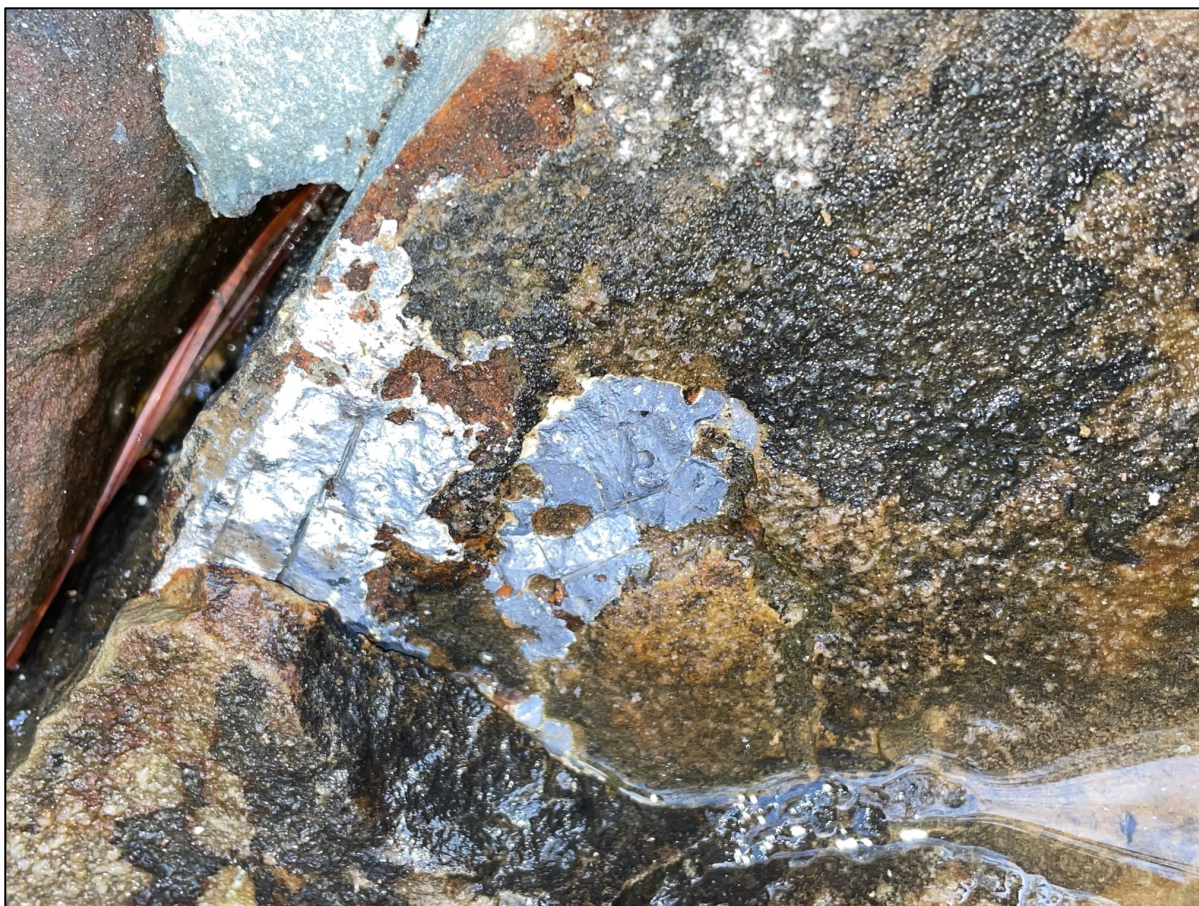
Figure 4 (right): Galena vein found in sandstone sample.

The few hand samples of galena were found in the upper portion of the left fork in the stream; however, the exact location of the mine was unclear, suggesting that there was sufficient burial of the minerals to inhibit leaching and the formation of acid mine drainage.
